AERONAUTICAL RESEARCH LABORATORIES

Structures Technical Memorandum 365

RETRACTION AND LOWERING OF THE MIRAGE UNDERCARRIAGE

The retraction and lowering process on the aircraft and operation of the jacks in the laboratory were investigated following a failure to lock down.

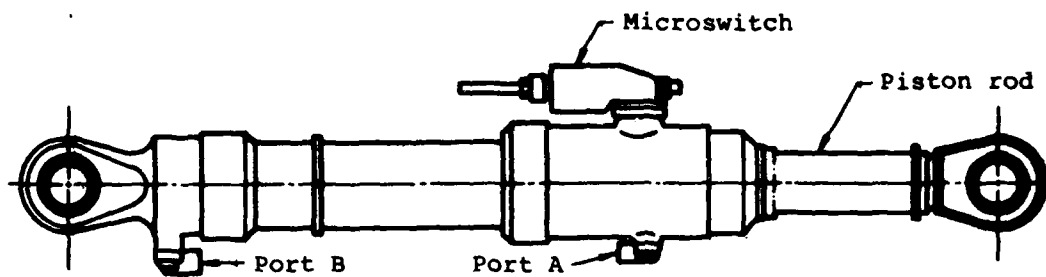
FIG 1(a) RETRACTION ACTUATOR - MAIN UNDERCARRIAGE

When the undercarriage is lowered the weight of the leg tends to extend the jack and the speed is controlled by a one-way restrictor in the return line, (connected to port A, Fig. 1). Pressure on the return side of the jack piston also acts on the locking piston. This displaces it to the 'unlock' position and compresses the spring, Fig. 1b. (Note that this figure, copied from the handbook, shows the locking piston being displaced by the locking claws but this will not occur during normal operation). When the leg is fully extended the hydraulic flow ceases and the back pressure in the return line falls, the spring then returns the locking piston to the lock position.

The jack could fail to lock if:

- (1) The jack is not fully extended so that the engagement of the locking claws is incomplete.
- (2) The locking piston is not returned to the lock position.

Return of the locking piston could be impeded by excessive back pressure, inadequate spring force or excessive sliding friction. The principal objective of the tests on the aircraft was to check back pressures (return line pressure) while the jack extended and locked.

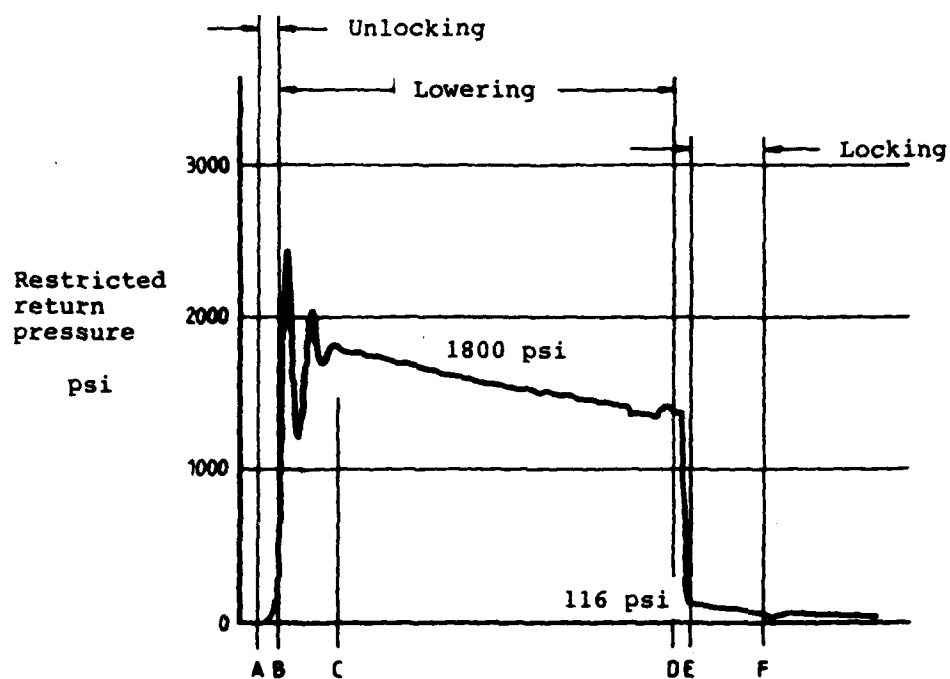
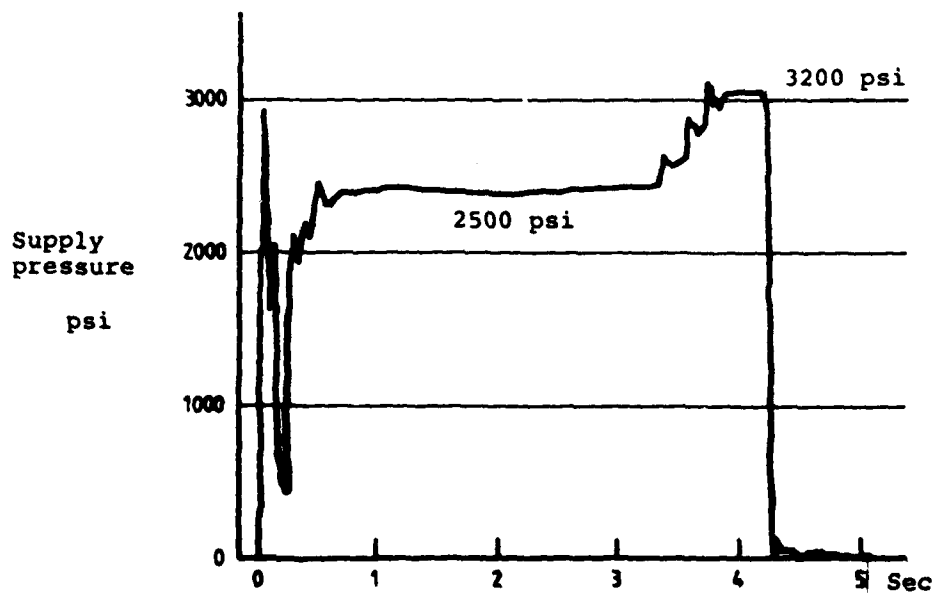
FIG 2 MIRAGE MAIN UNDERCARRIAGE LOWERING LATERAL JACK PRESSURES - A3-03 STARBOARD

Reference	Event	Approx Pressure p.s.i.	
		Supply	Return
A	Pressure applied to release up-lock and lower leg.	3000	0
A-B	Leg falls; pressure in return side moves lock piston compressing spring. Flow out of jack restricted.		
B-C	Pressure fluctuates as leg 'bounces' on jack.		
C-D	Steady lowering established. Return pressure on piston balances gravity moment plus supply pressure acting on smaller piston area. Return pressure diminishes as leg gets more vertical.	2500	1800
D-E	Leg down, flow censes, return pressure drops, supply pressure increases to system pressure.	3200	
E-F	When return pressure falls to 116 psi, spring moves locking piston, displacing fluid through the restrictor and maintaining a pressure of 116 to about 80 psi.		
F	When fully locked the micro switch operation cuts off hydraulic pressure. Supply and return pressures fall to very low values.	0	22

Note: Flow rates and pressures across the restrictor during C-D and E-F both correspond to the specified restrictor performance.

This was slower than normal operation but engagement of the lock with pressure variation as shown on the upper trace of Fig. 2 E-F was evident.

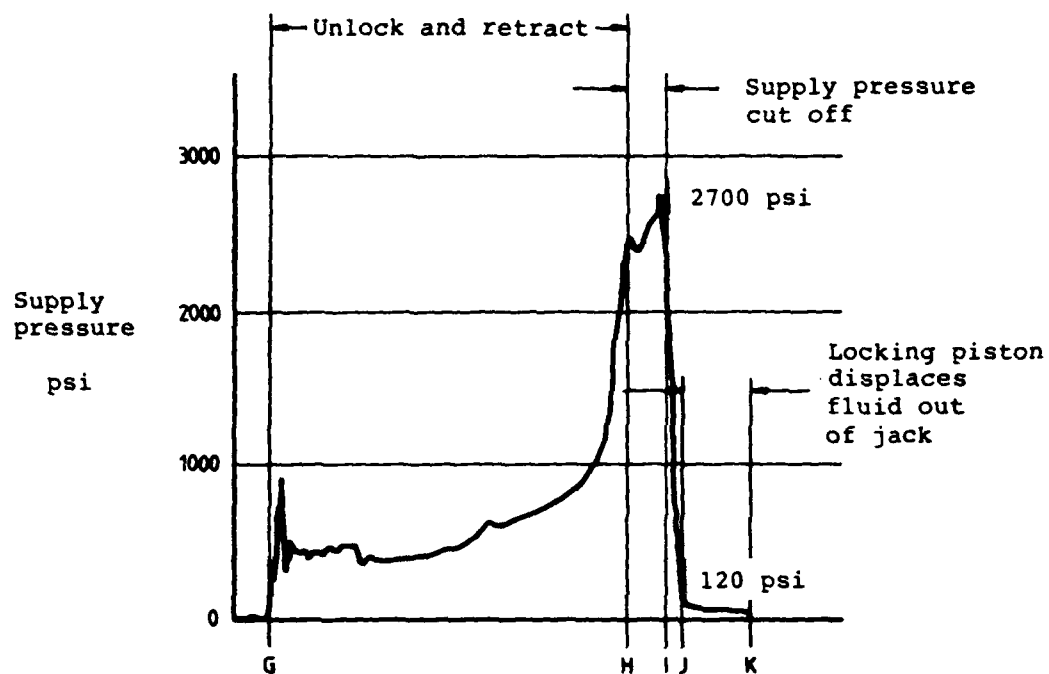
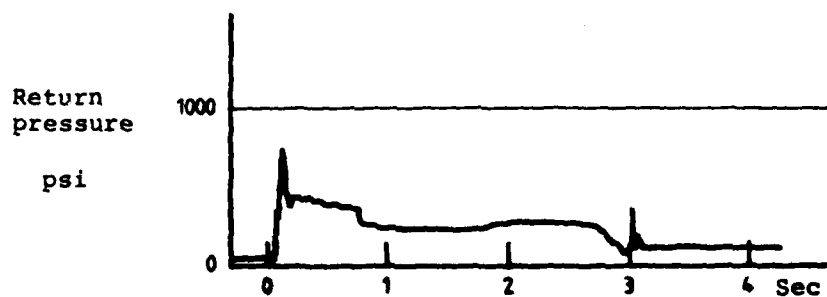
FIG 3 MIRAGE MAIN UNDERCARRIAGE RETRACTION LATERAL JACK PRESSURES A3-03 STARBOARD

Reference	Event
G	Pressure surge into jack on selection "up" unlocks locking piston and accelerates jack causing surge in return line. (Note: one-way restrictor in "supply" line to jack allows full flow for retraction).
G-H	Leg retracts with increasing pressure as gravi moment increases. Internal "snubbing" in jack slows leg just before "up" (H) increasing "sup" pressure and reducing "return" pressure.
H-I	Leg "Up" doors close, supply pressure cut at I
I-J	Pressure decreases to about 120 psi.
J-K	Locking piston moves under influence of spring to displace fluid out of jack against one-way restrictor. This corresponds to the final stage of "Lowering" (E-F) Fig. 2. At K pressure in supply lines fell to less than 30 psi. Return line pressure also less than 30 psi.
